New York State Department of Transportation General Bridge Inspection Report

Inspection Date: April 22, 2021

BIN: 1031701

Feature Carried: 81I 81I33033050

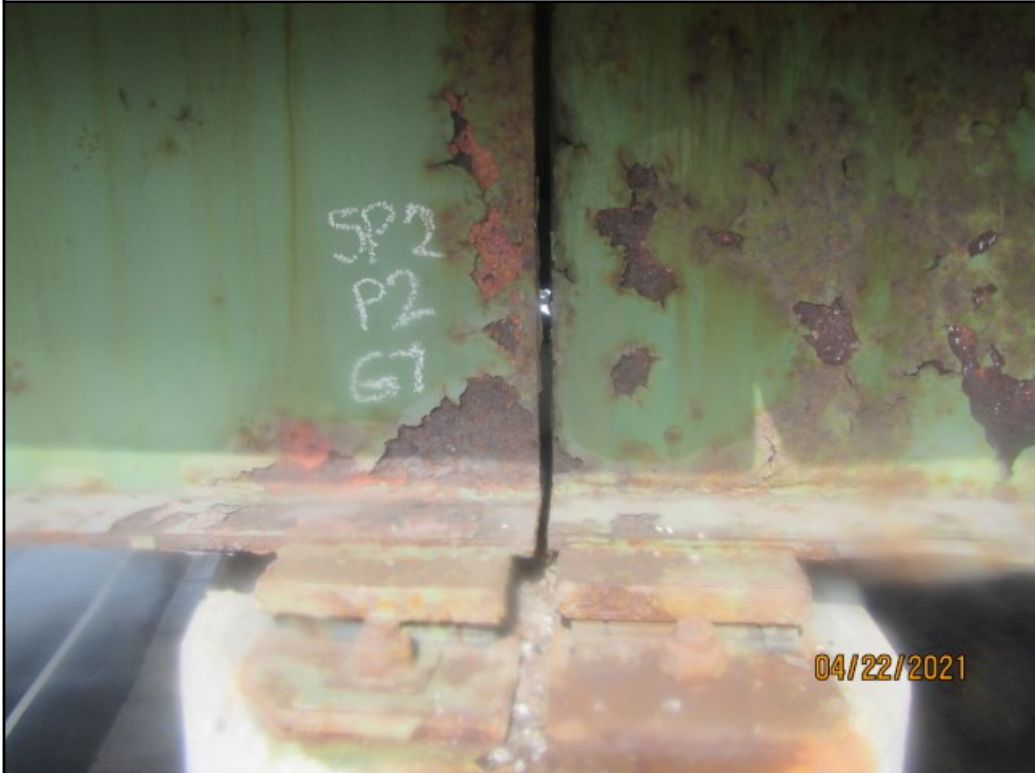
Photo Number: 1

The paint has failed on 30% of the bearing components (Pic#23) and 50% of the galvanization has failed on the bridge rail (Pic#29&36) has allowing base metal to corrode in all three spans. The G1 and G7 fascia bearings (Pic#1,11,13&38) have about 70% paint failure.

Attachment Description: 1
Pier 2 G7 bearings.JPG

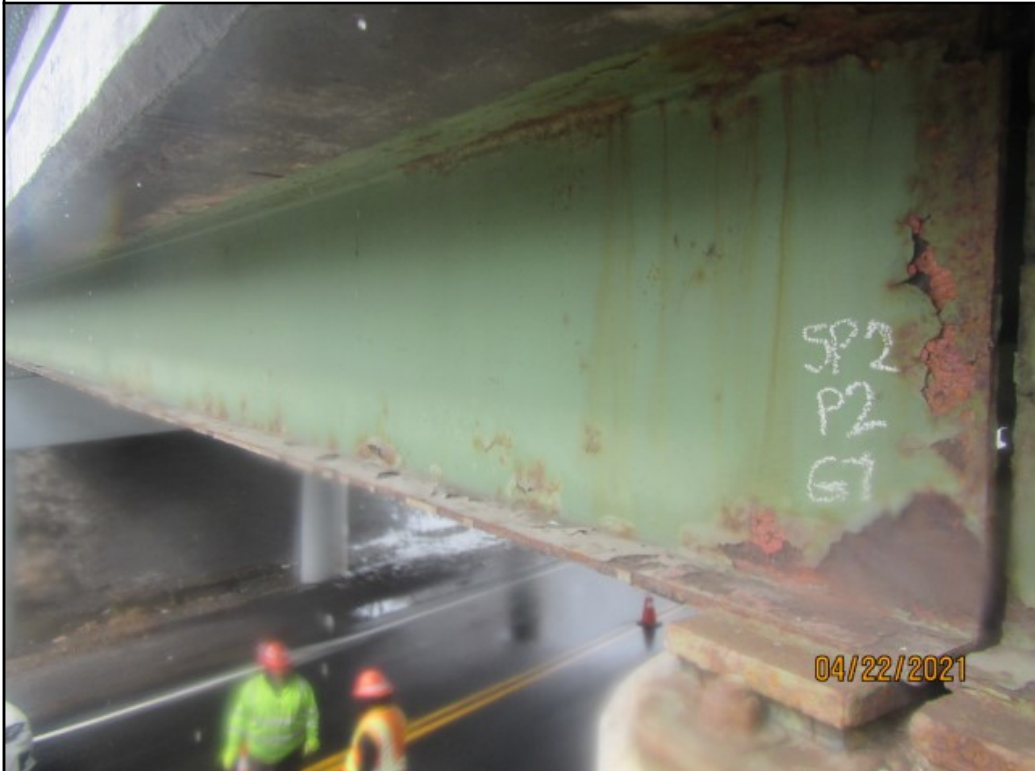
Photo Number: 2

The paint has failed on 10% of the overall area of the girders, floor beams, and stringers in all 3 spans allowing corrosion to form with section loss starting in localized areas (Pic#2,3,9,10,12,13,14,15,16,46&49). All layers of the paint have peeled off in large sheets in several areas at the lower webs and bottom flanges (Pic#47).

Attachment Description: 2
Span 2 G7 facing
Begin.JPG

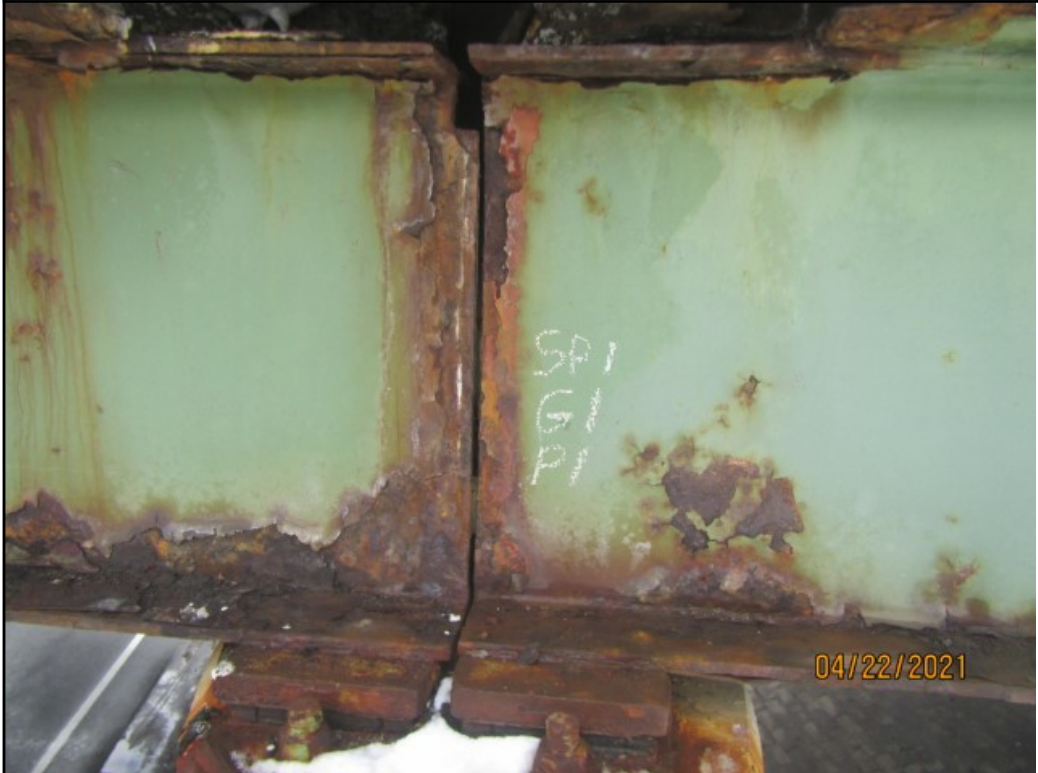
Photo Number: 13

Attachment Description:
13 G1 over Pier 1.JPG

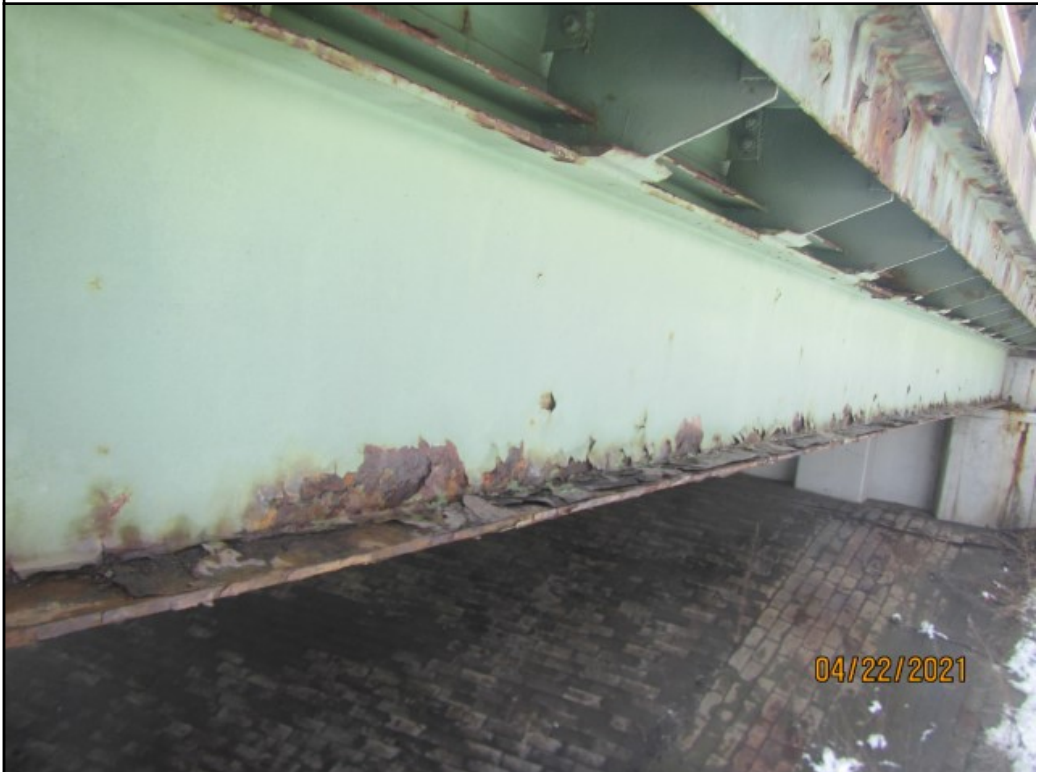
Photo Number: 14

Attachment Description:
14 Span 1 G1 facing
Begin.JPG

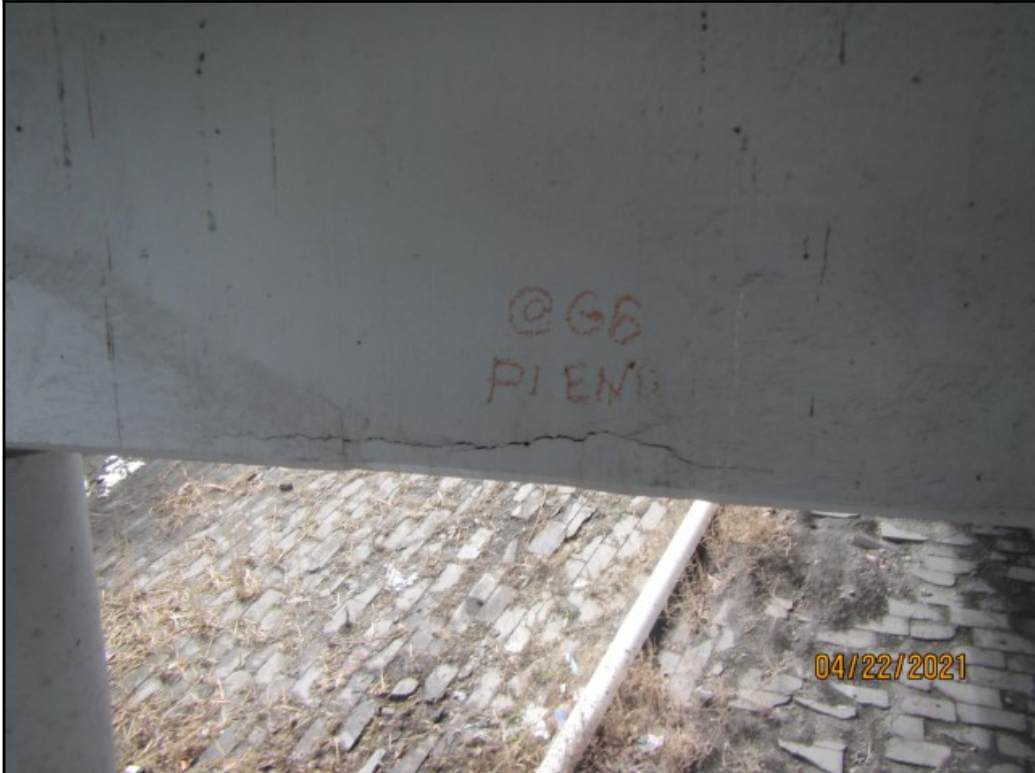
Photo Number: 19 Photo Filename: 19a Pier 1 cap beam End face at G6.JPG

Pier 1 - The cap beam in bay 1 has a 2.5' long crack on its end face and underside (Pic#17) upto 1/8" wide. Under G5 at the end face of the pier cap there is a 4' long long horizontal crack at the bottom corner upto 1/8" wide. Under G6 at the end face of the pier cap there is a 3' long horizontal crack at the bottom corner (Pic#19) upto 1/8" wide.

Attachment Description:
19 Pier 1 cap beam End
face at G6.JPG

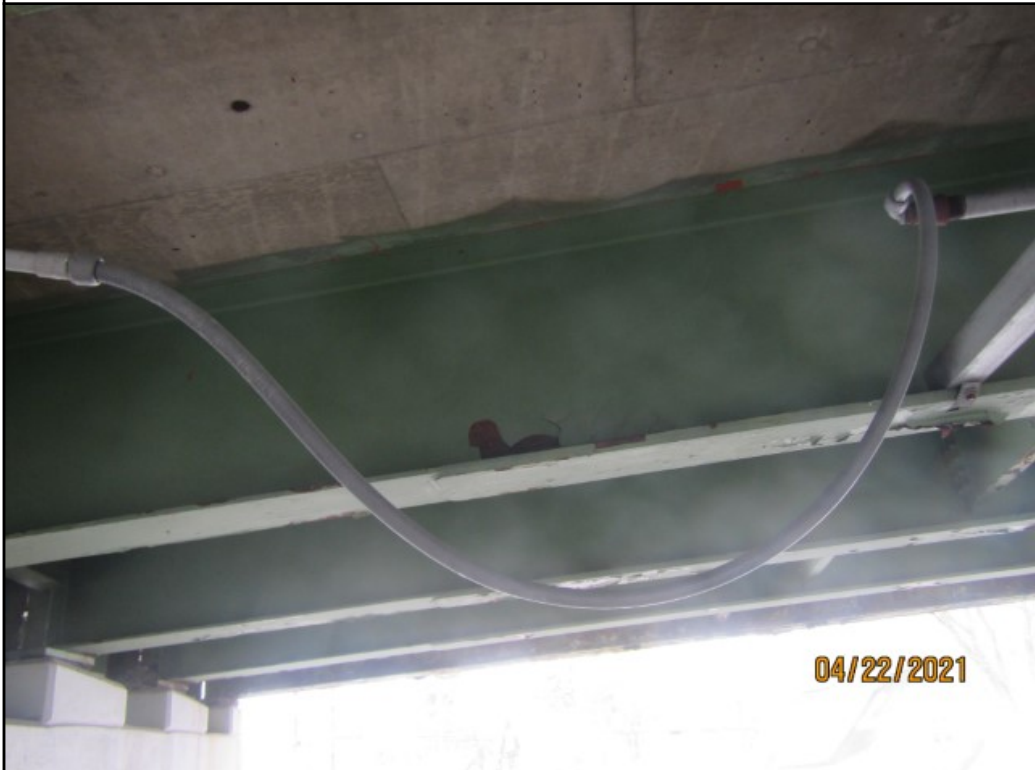
Photo Number: 20 Photo Filename: 20a Hanging Conduit at Span 2 G5.JPG

There is hanging conduit in span2 bay5.

Attachment Description:
20 Hanging Conduit at Span
2 G5.JPG

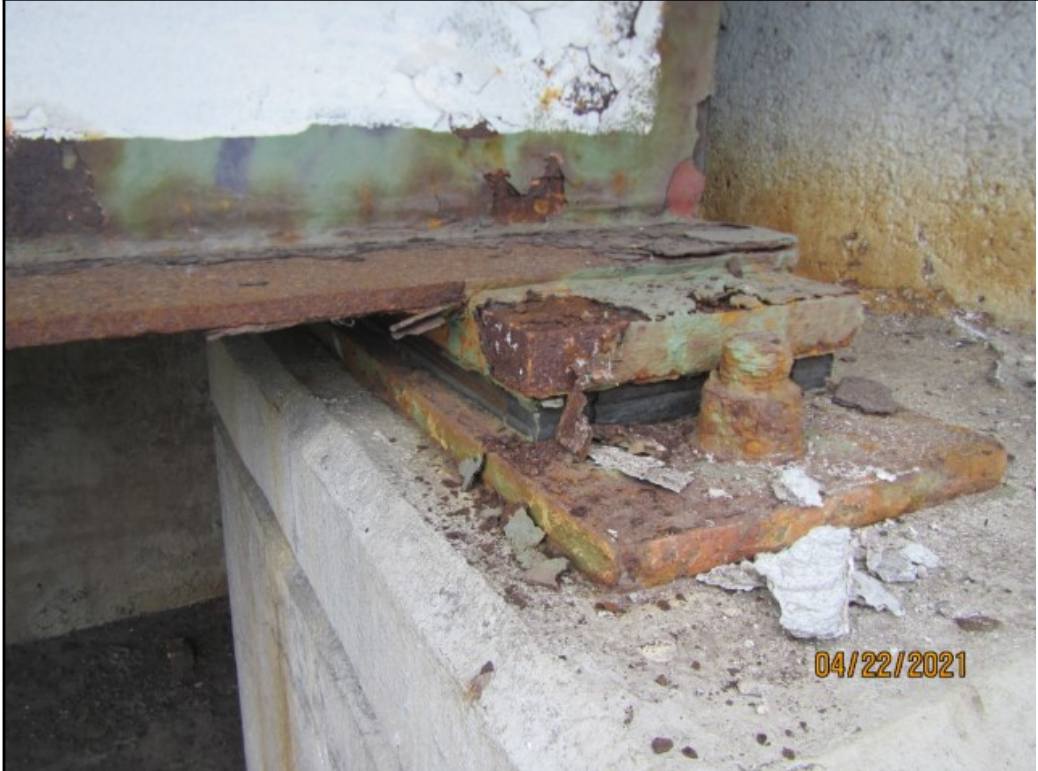
Photo Number: 23

Attachment Description:
23 End G7 bearing.JPG

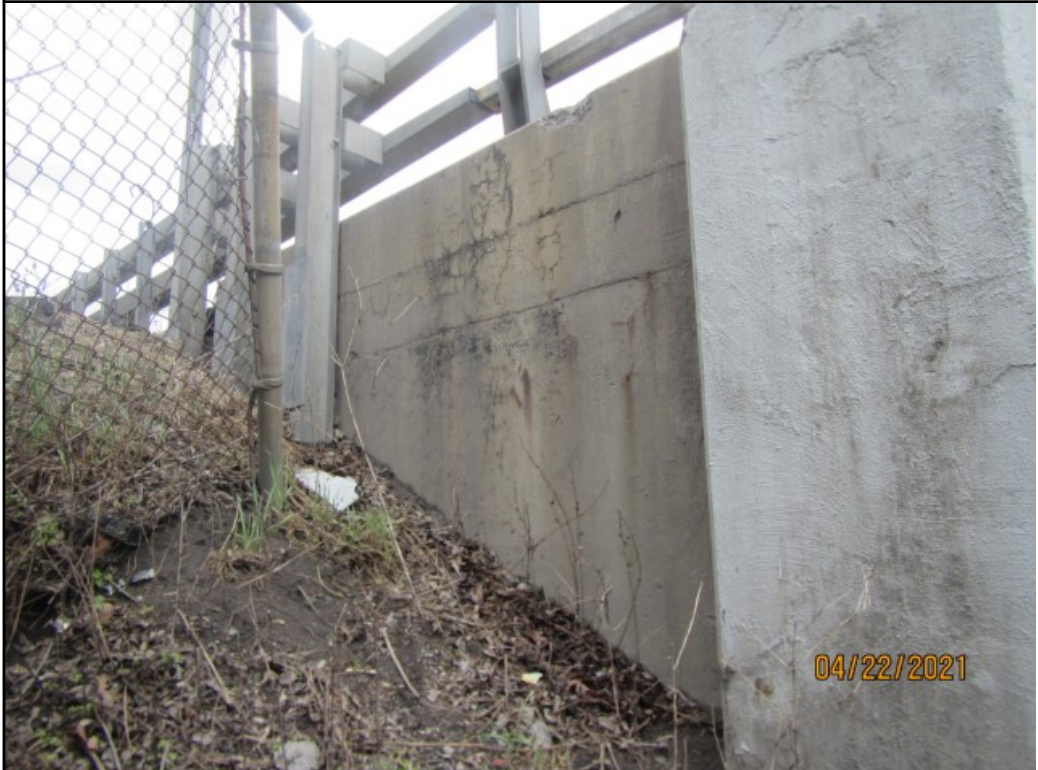
Photo Number: 24

The End Left wingwall has a 1 foot long by 2 inch deep spall at the top corner near the abutment and an 8ft long x 5ft high section of map cracking with efflorescence and rust staining. See CS note for element EA853.

Attachment Description:
24 End Left wingwall.JPG

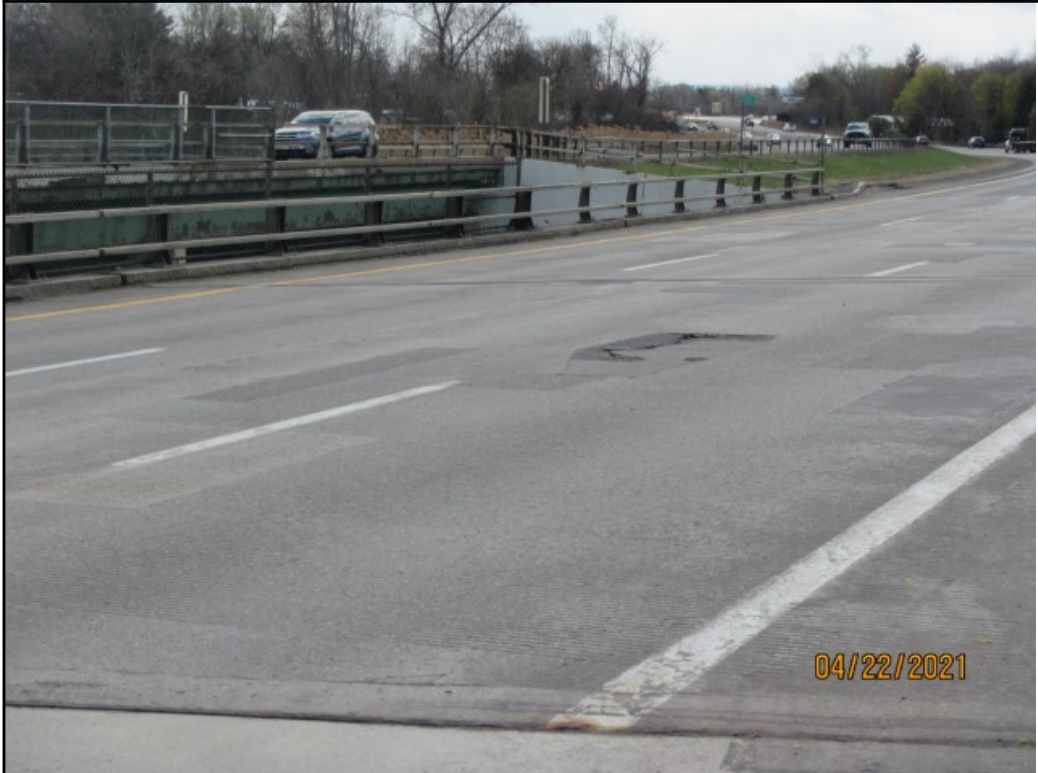
Photo Number: 27 Photo Filename: 27a Span 3 wearing surface from End Left (1).

Upgrade the CS4 quantity to CS2. The previously down rated asphalt patches have been repaired (Pic#30,31&33) but there are new locations in all three spans with deteriorated patches (Pic#27&34) and there are scattered cracks throughout upto 1/8 inch wide over 10% of the area. There is a 1' wide x 15' long section of deteriorated concrete (Pic#32) along the Left shoulder of span2

Attachment Description:
27 Span 3 wearing surface
from End Left.JPG

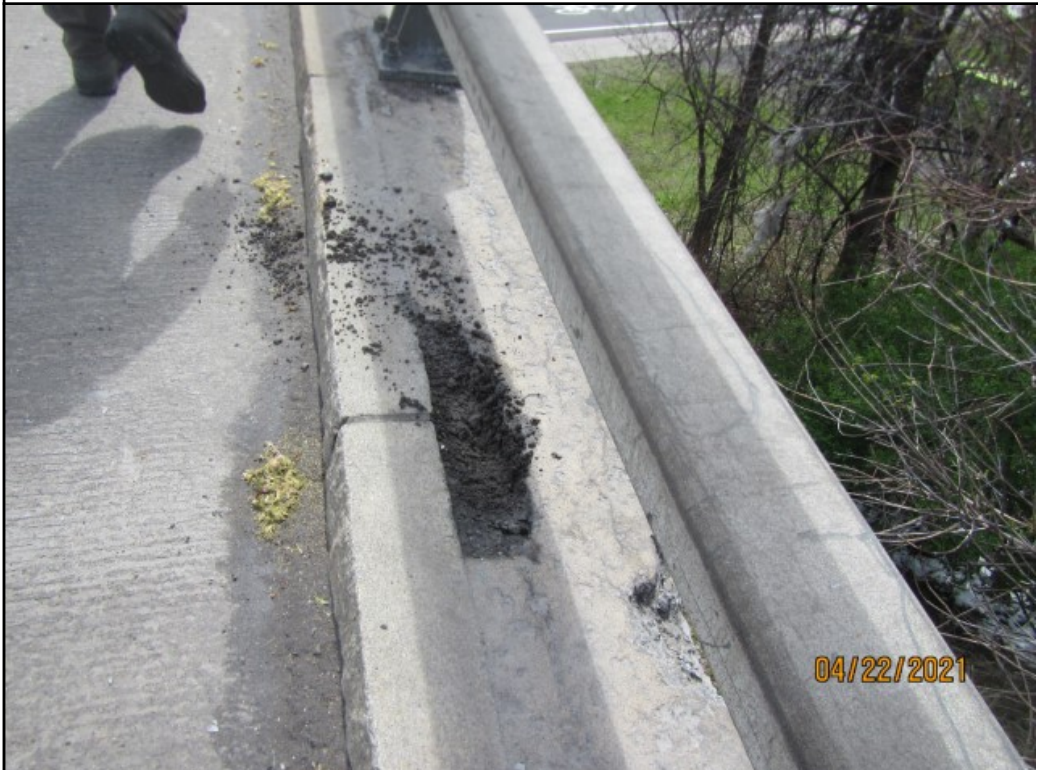
Photo Number: 28 Photo Filename: 28a Span 3 Left side facing Begin.JPG

The concrete rail post base is deteriorated over 20% of its length (Pic#28,29&32) behind the curb and there is a 2' x 6" spall (Pic#45) on the Right fascia.

Attachment Description:
28 Span 3 Left side facing
Begin.JPG

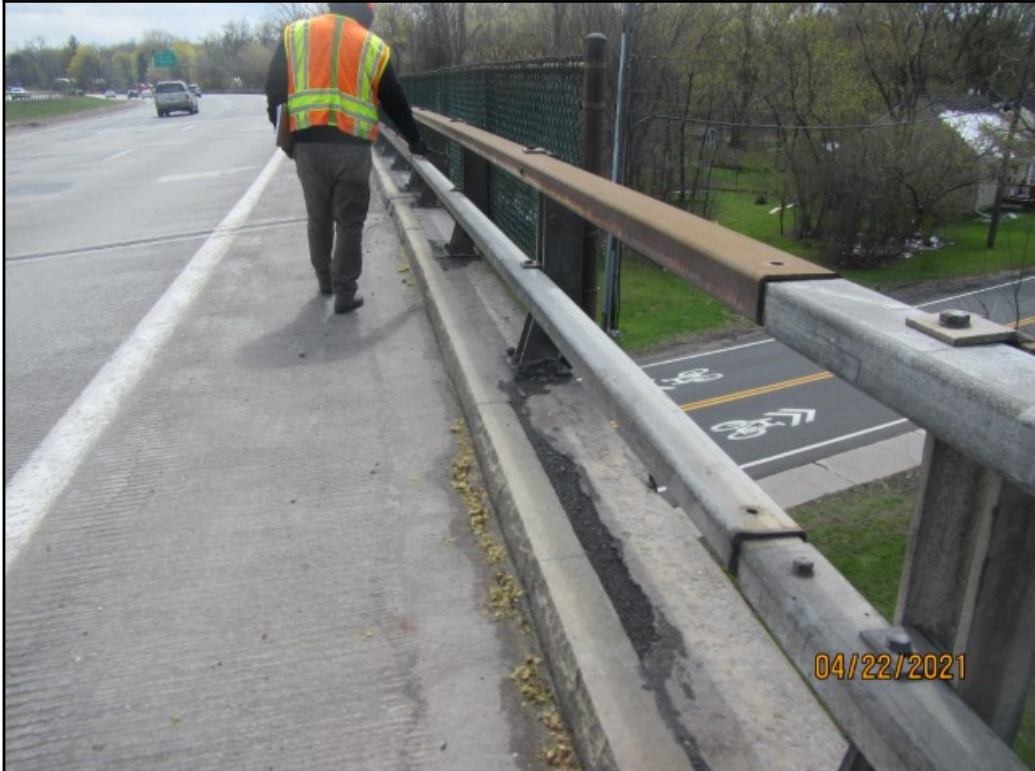
Photo Number: **29** Photo Filename: **29a Span 2 Left side rail facing Begin.JPG**

Attachment Description:
29 Span 2 Left side rail
facing Begin.JPG

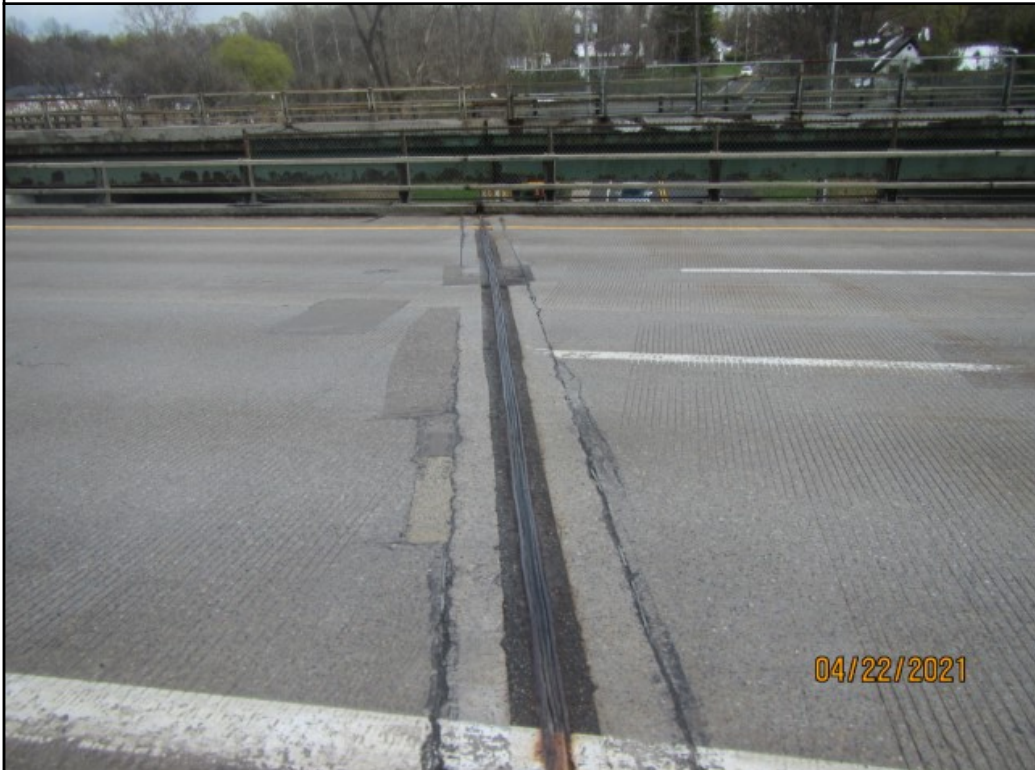
Photo Number: **30** Photo Filename: **30a Pier 2 joint facing Right (2).JPG**

The joints at Piers 1 and 2 are both leaking moderately full length causing the underside of the joint headers to spall exposing reinforcing and causing deterioration to the elements below. The right half of the joint at Pier 1 has a torn seal. The begin concrete header is spalled 5 ft long by 1 1/2 inch deep right of the center lane (Pic#33) adjacent to the spalled wearing surface. Concrete header of the Pier 2 joint shows spalling along the edges for 20 ft at the right (Pic#30).

Attachment Description:
30 Pier 2 joint facing
Right.JPG

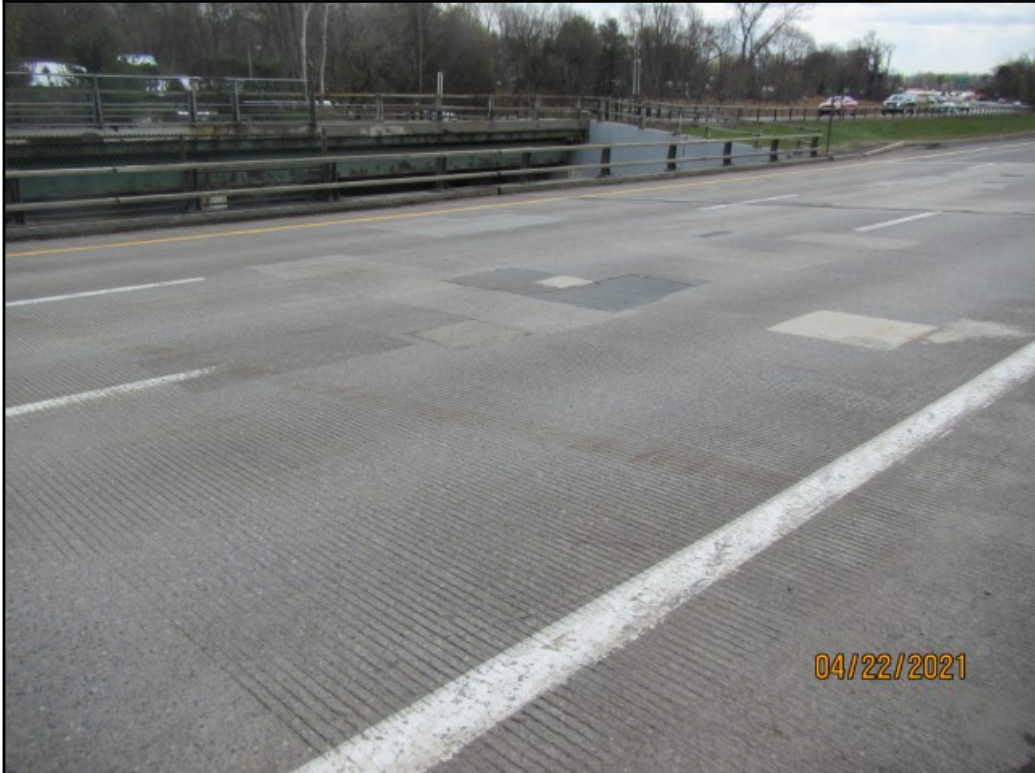
Photo Number: 31

Attachment Description:
31 Span 2 wearing surface facing Begin.JPG

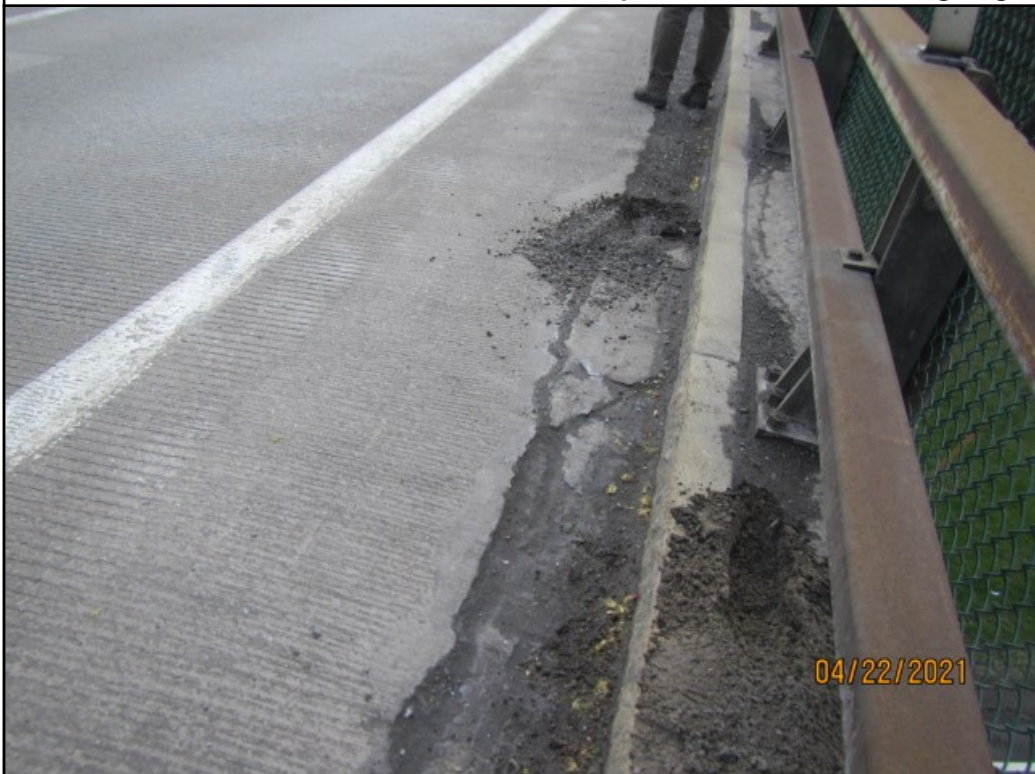
Photo Number: 32

Attachment Description:
32 Span 2 Left shoulder facing Begin.JPG

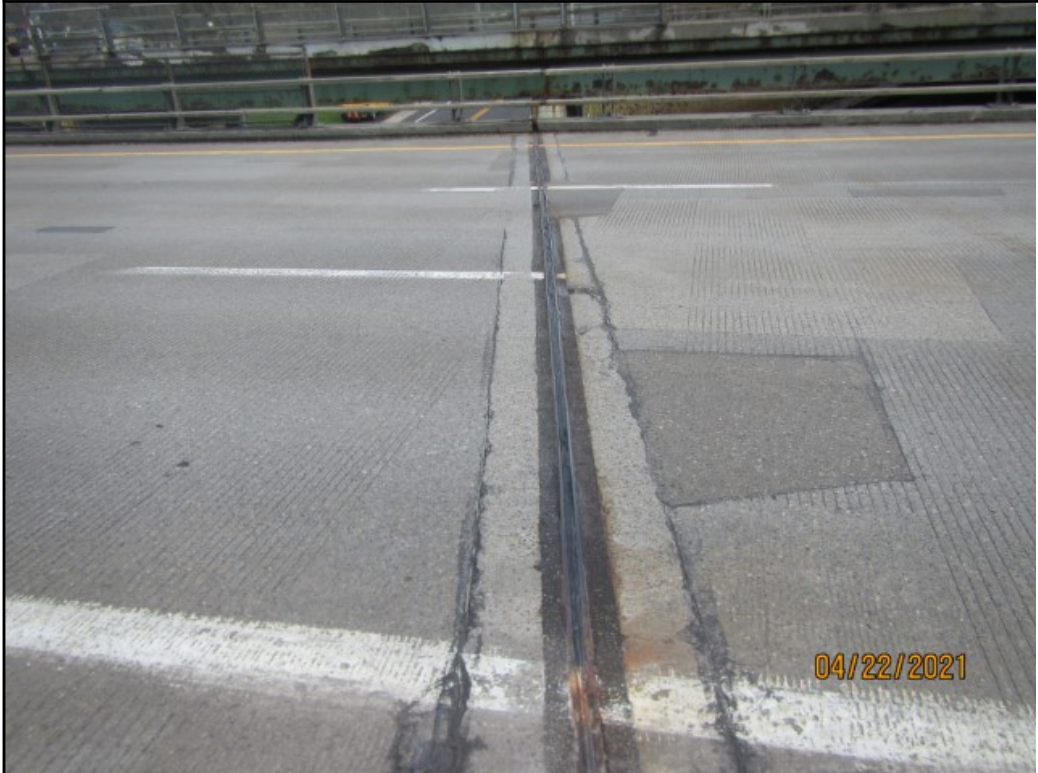
Photo Number: 33

Attachment Description:
33 Pier 1 joint facing
Right.JPG

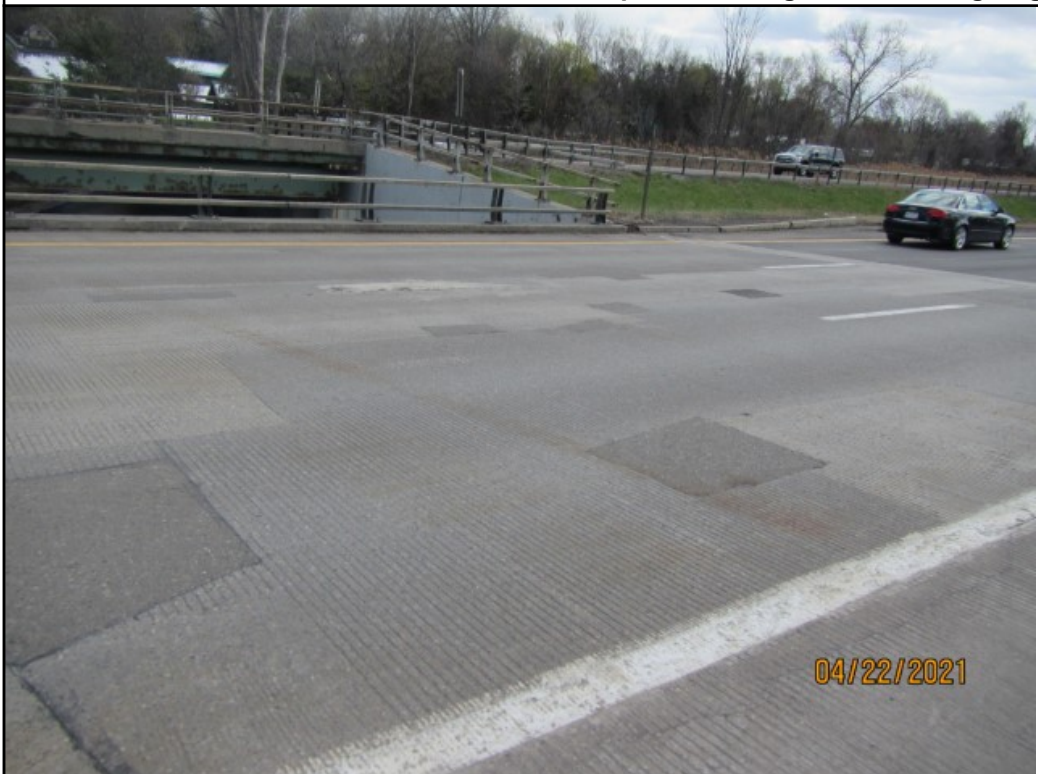
Photo Number: 34

Attachment Description:
34 Span 1 wearing surface
facing Begin.JPG

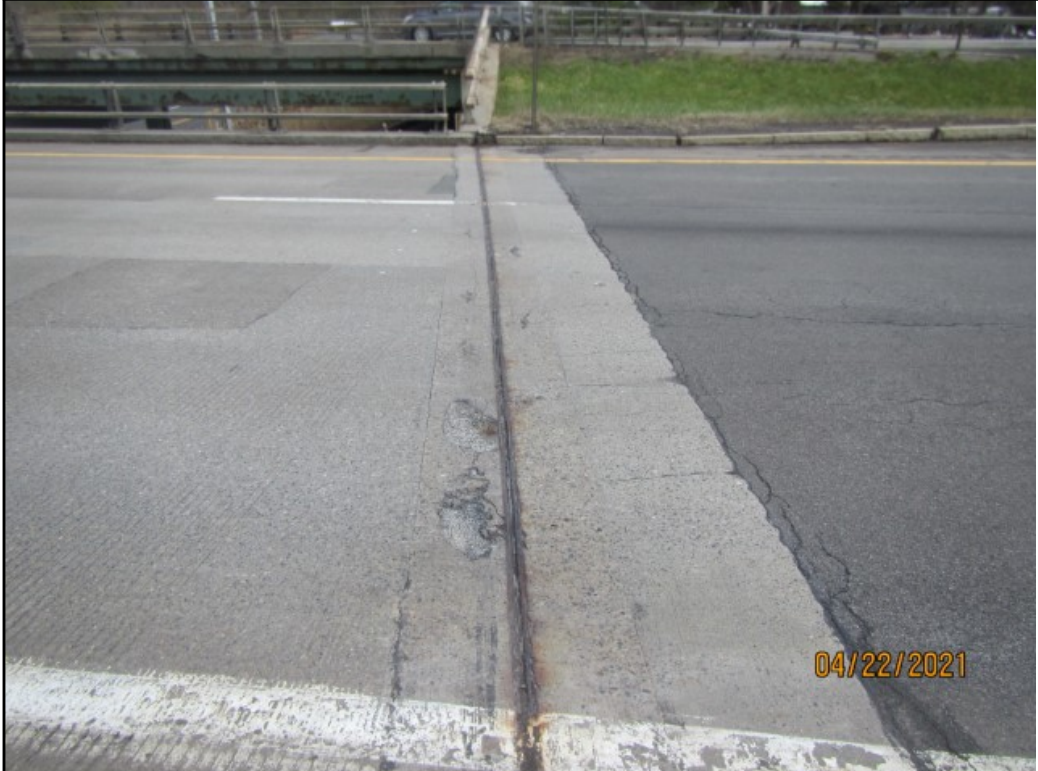
Photo Number: 35

Both the Begin (Pic#35) and the End (Pic#21) joint seals have debonded over about 25% of their length and are leaking moderately full length causing the underside of the joint headers to spall exposing reinforcing and causing deterioration to the elements below

Attachment Description:
35 Begin joint facing
Right.JPG

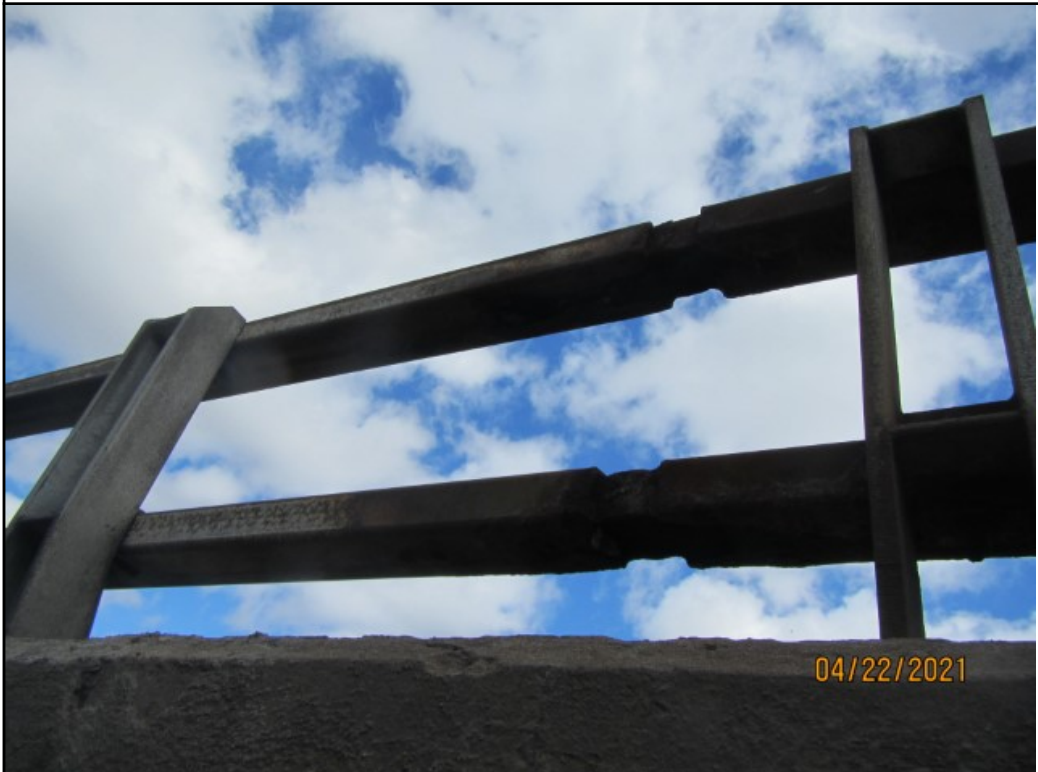
Photo Number: 36

Attachment Description:
36 Span 1 rail Left side.JPG

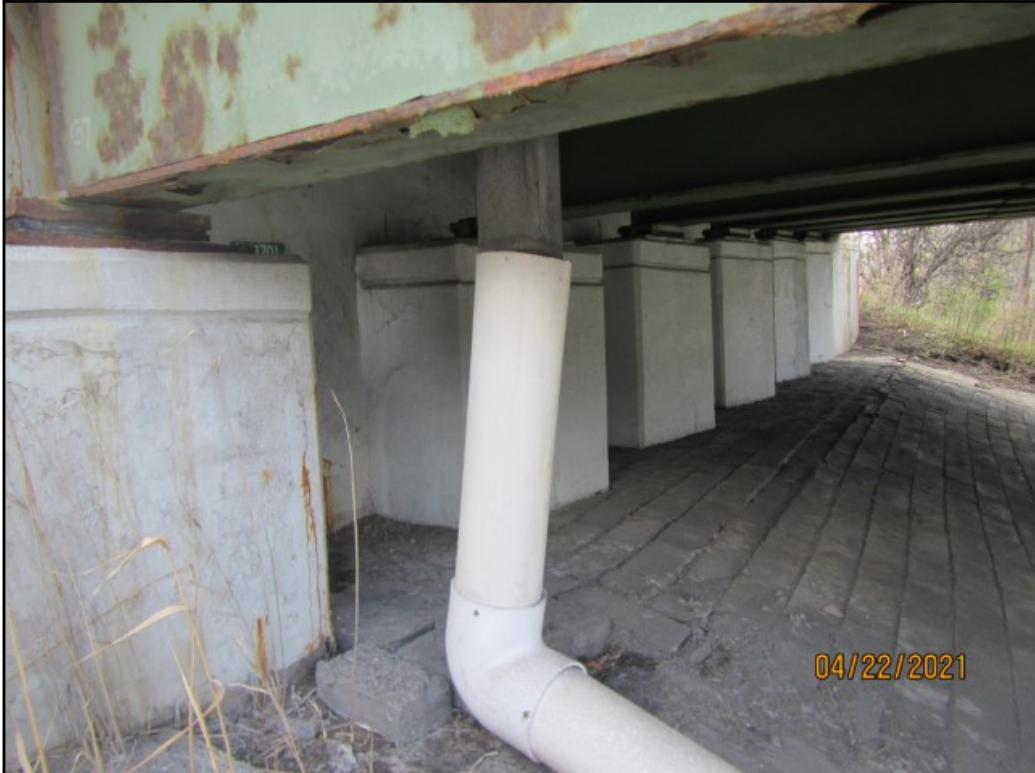
Photo Number: 39

Span 1: BA800 - Erosion or Scour Span 3: EA800 - Erosion or Scour	TQ	CS-1	CS-2	CS-3	CS-4	CS-5
	83	0	77	6	0	0
	65	0	59	6	0	0
Condition State 3 Note Referenced Photo(s): 39 Referenced Sketch(es): None						
There is an erosion gully approximately 6 feet wide below G7 at the begin and end abutment. The concrete block pavers in this area are disturbed and eroded down the entire slope due to the presence of the scupper outlets near the begin and end abutments. No footings are exposed.						
Span 1: 811 - Curb Span 2: 811 - Curb Span 3: 811 - Curb	TQ	CS-1	CS-2	CS-3	CS-4	CS-5
	100	75	25	0	0	0
	102	0	96	6	0	0
Span 1: 811 - Curb Span 2: 811 - Curb Span 3: 811 - Curb	TQ	CS-1	CS-2	CS-3	CS-4	CS-5
	100	0	97	3	0	0
	100	0	97	3	0	0
Condition State 3 Note Referenced Photo(s): 29 Referenced Sketch(es): None						
The concrete behind the curb is rated as bridge rail post anchorage. See element 330						
Span 1: BA850 - Backwall	TQ	CS-1	CS-2	CS-3	CS-4	CS-5

Attachment Description:
39 Begin Right
Abutment.JPG

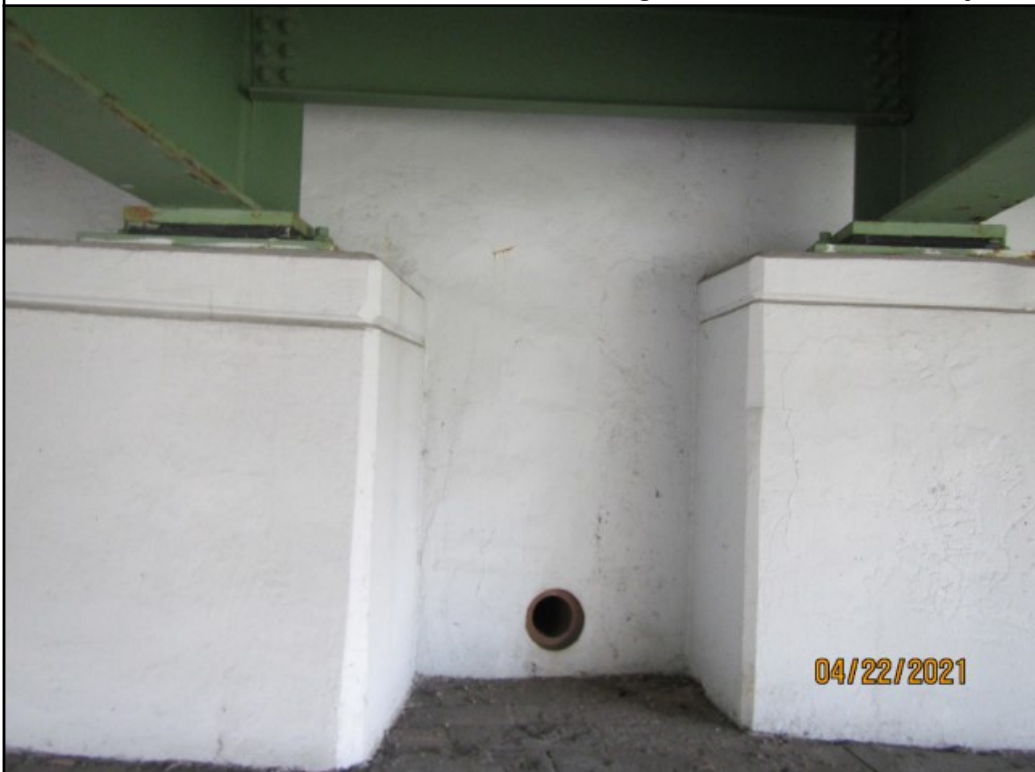
Photo Number: 40

78	0	65	13	0	0
	78	0	65	13	0	0
Common Referenced Photo(s): 37, 40, 43 Referenced Sketch(es): None						
The bay4 backwall has been previously repaired and painted (Pic#40). The top of the begin backwall is spalled 3 inches deep by 1 1/2 foot wide by 2.5 feet high on the Right side of G7 (Pic#37) with exposed rebar.						
The right side of the begin abutment is assessed as backwall. There are 3 spalls near the top within 6 feet of the right fascia (Pic#43). Each of the spalls are approximately 3 inches deep by 1 foot high by 1 foot wide over a length of 6 ft.						
The Begin Left structure is assessed as wingwall.						
Span 1: BW853 - Wingwall	TQ	CS-1	CS-2	CS-3	CS-4	CS-5
	13	8	0	5	0	0
	13	8	0	5	0	0
Condition State 3 Note Referenced Photo(s): 41 Referenced Sketch(es): None						
The Begin Left WW structure is spalled upto 3 inches deep by 8 inches high on its top corner over a 5 feet length. See CS note for element BA853

Attachment Description:
40 Begin abutment backwall
Bay 4.JPG

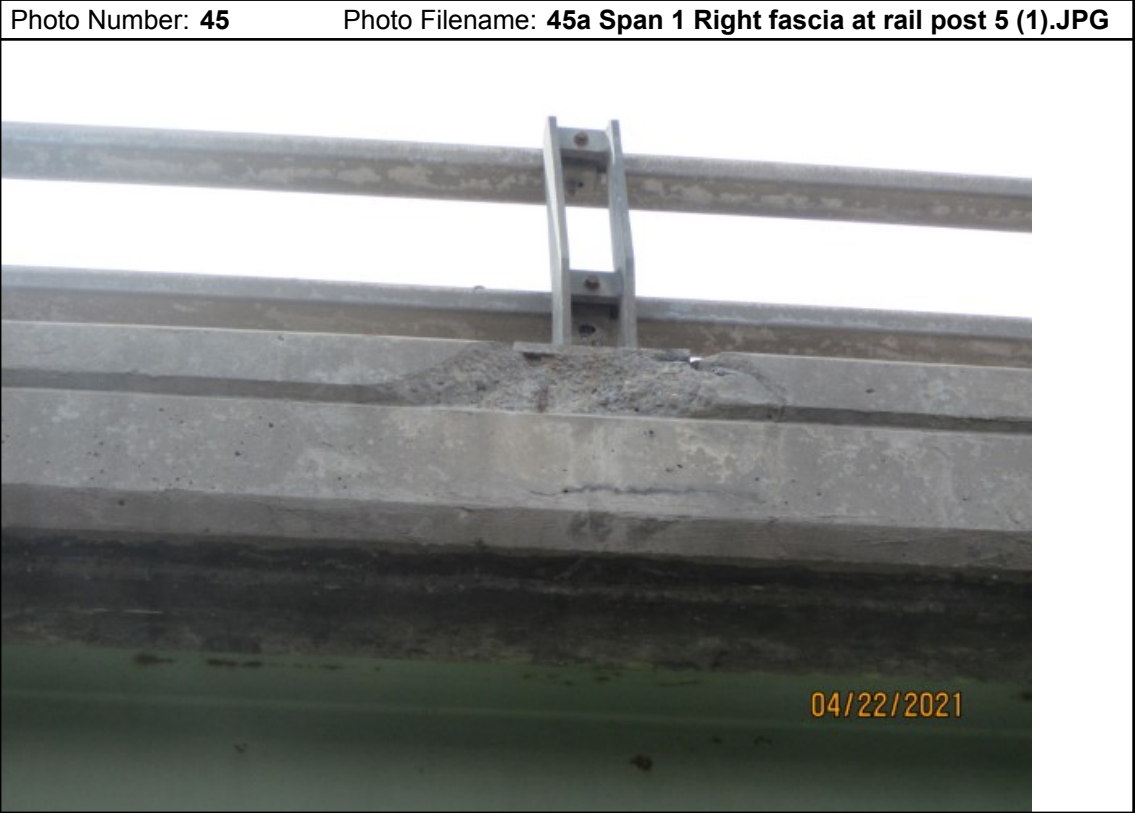
Attachment Description:
45 Span 1 Right fascia at rail post 5.JPG

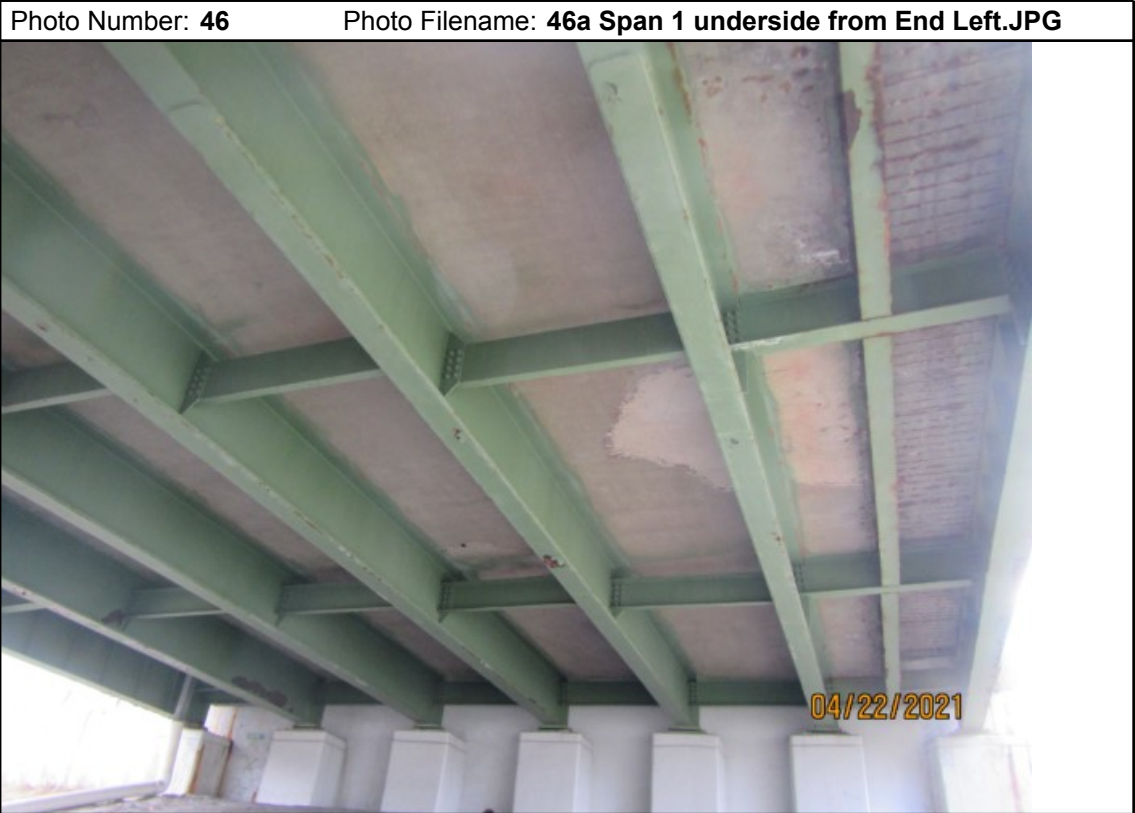
Attachment Description:
46 Span 1 underside from End Left.JPG
